# **James Webb Space Telescope (JWST) Integrated Science Instrument Module (ISIM) Cryo-Vacuum (CV) Test Campaign Summary**

29<sup>th</sup> Space Simulation Conference  
NASA Goddard Space Flight Center  
(GSFC)

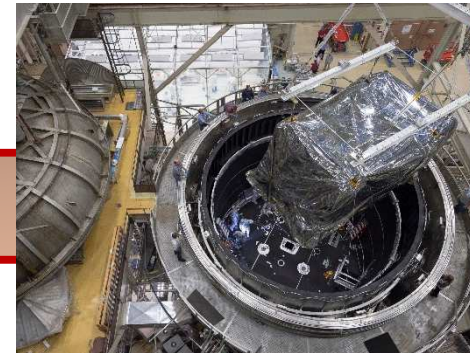
## CV3

CV3: Verify ISIM in its final configuration after environmental exposure and provide a post-environmental performance baseline (including critical ground calibrations for science data processing in flight)

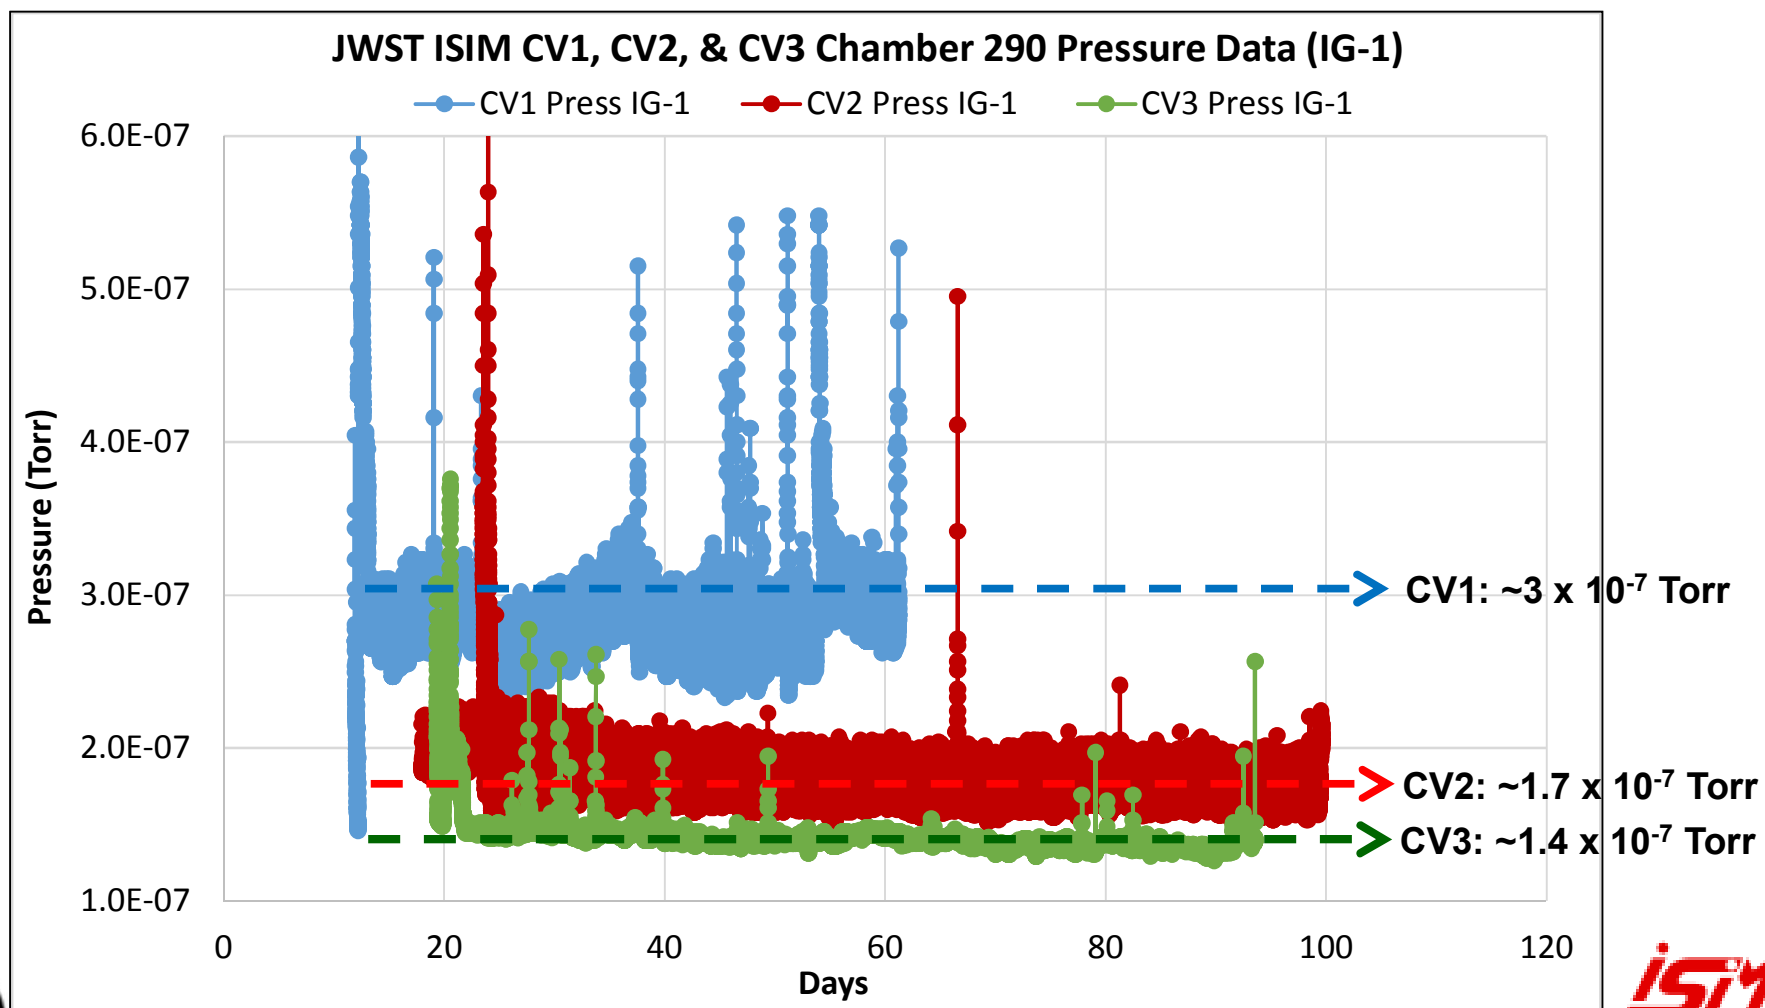
## Chamber Vacuum Performance: CV1 vs. CV2 vs. CV3

During steady-state (cool-down & warm-up omitted), vacuum pressure improved with each CV test

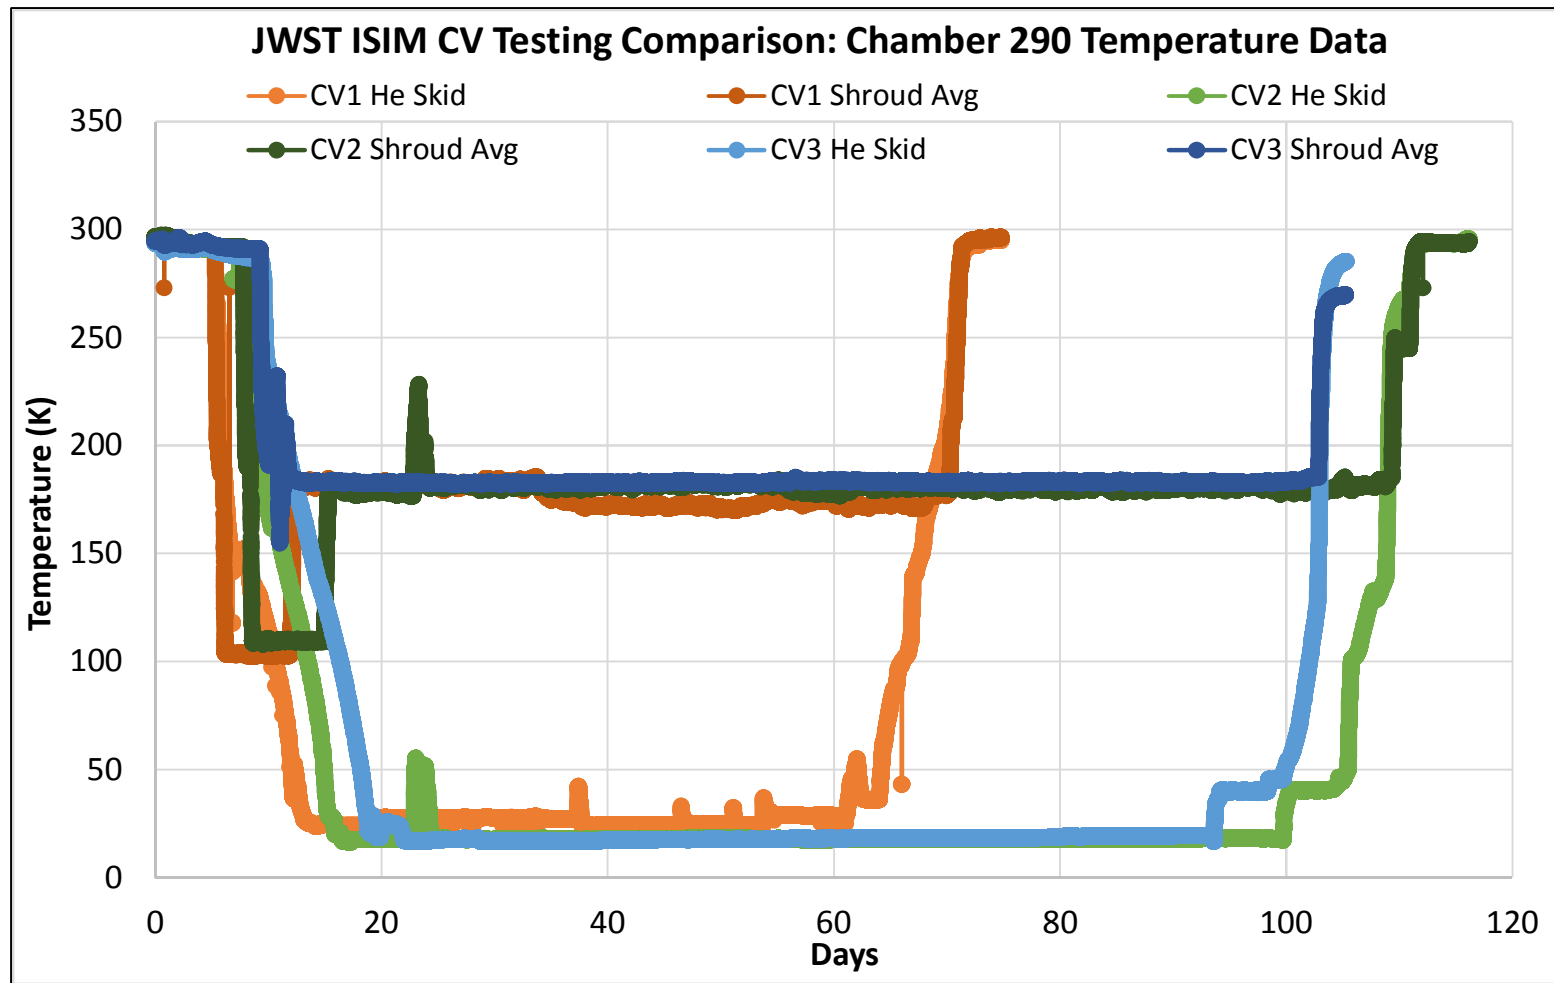
# Shrouds Temp Performance CV1 vs. CV2 vs. CV3

At steady state: Helium shroud average achieved:  $18\text{K} \pm 1\text{K}$  ||  $\text{LN}_2$  shroud average:  $180\text{K} \pm 3\text{K}$

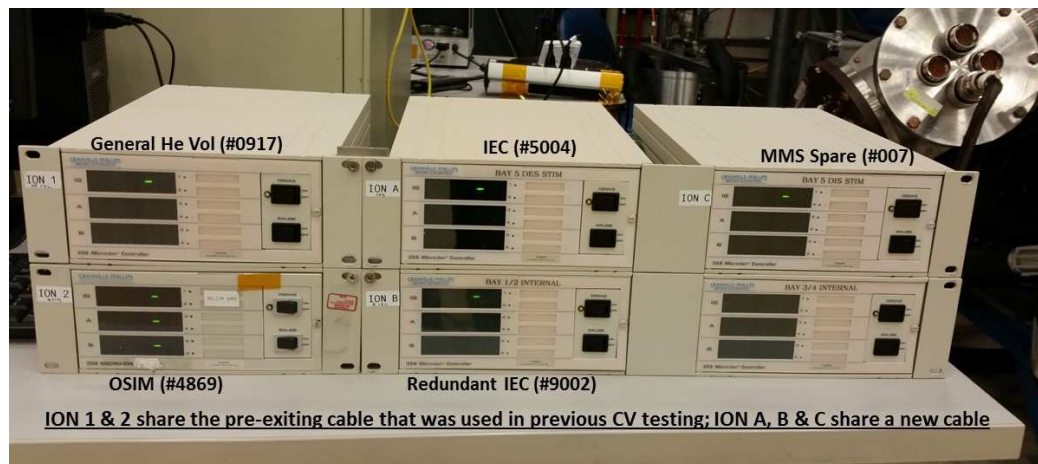
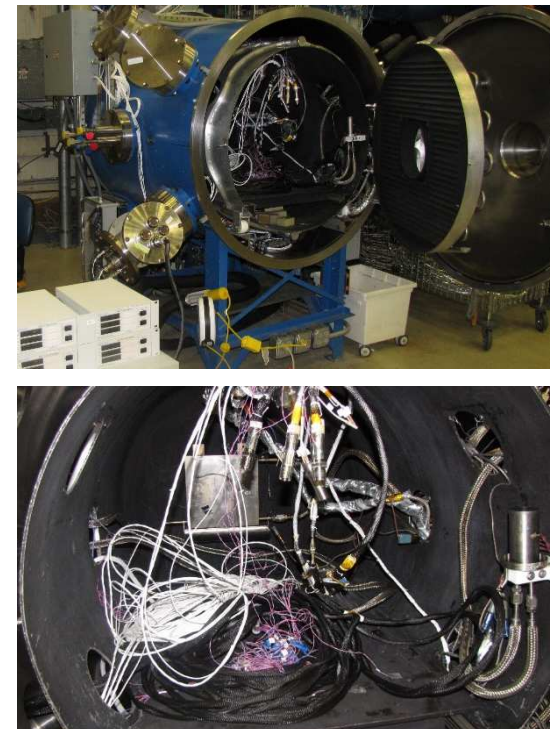
- Redundant micro ion gauge for IEC
- During check-out of the CV2 IGs, it was discovered that the extension used for the IEC IG was the root cause for the erratic and unreliable readings (per the spec sheet, maximum cable length allowable is 50')
- Cross-calibration of existing and new harnesses (+1 new redundant IEC micro IG) was performed in Facility 281

- During check-out of the CV2 IGs, it was discovered that the extension used for the IEC IG was the root cause for the erratic and unreliable readings (per the spec sheet, maximum cable length allowable is 50')
- Cross-calibration of existing and new harnesses (+1 new redundant IEC micro IG) was performed in Facility 281

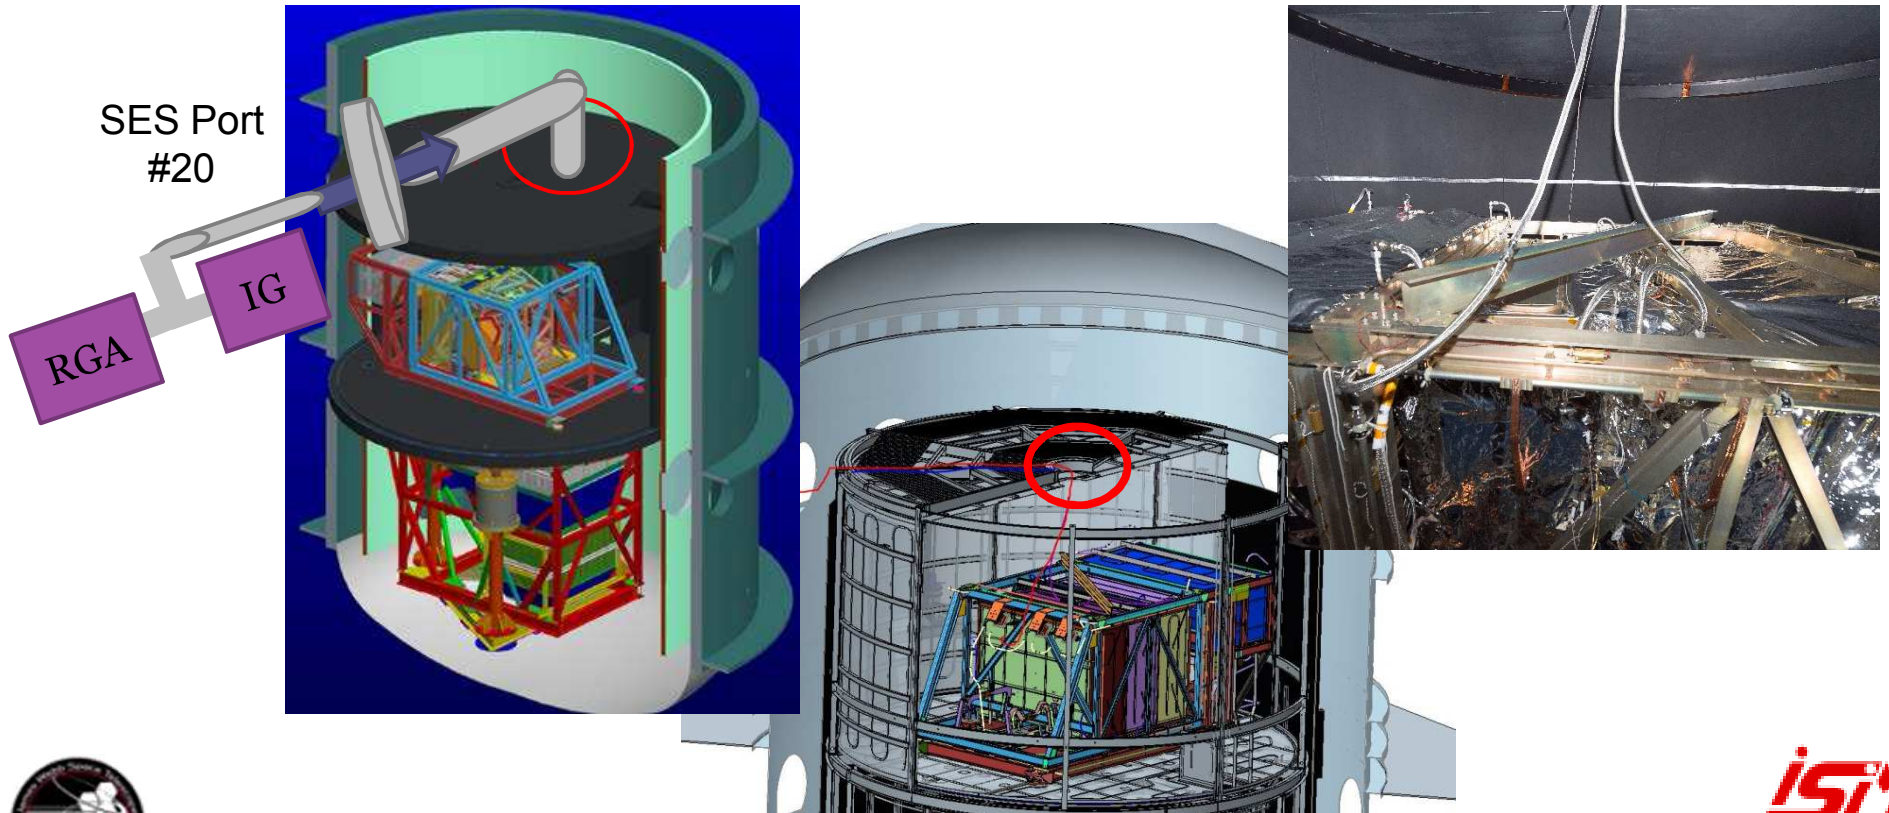
- Residual Gas Analyzer (RGA) to monitor STMS inside helium shroud
  - CV2: Added a RGA using flex lines into helium volume
  - CV3: Bought new calibrated RGA; used SS tubing instead of flex lines

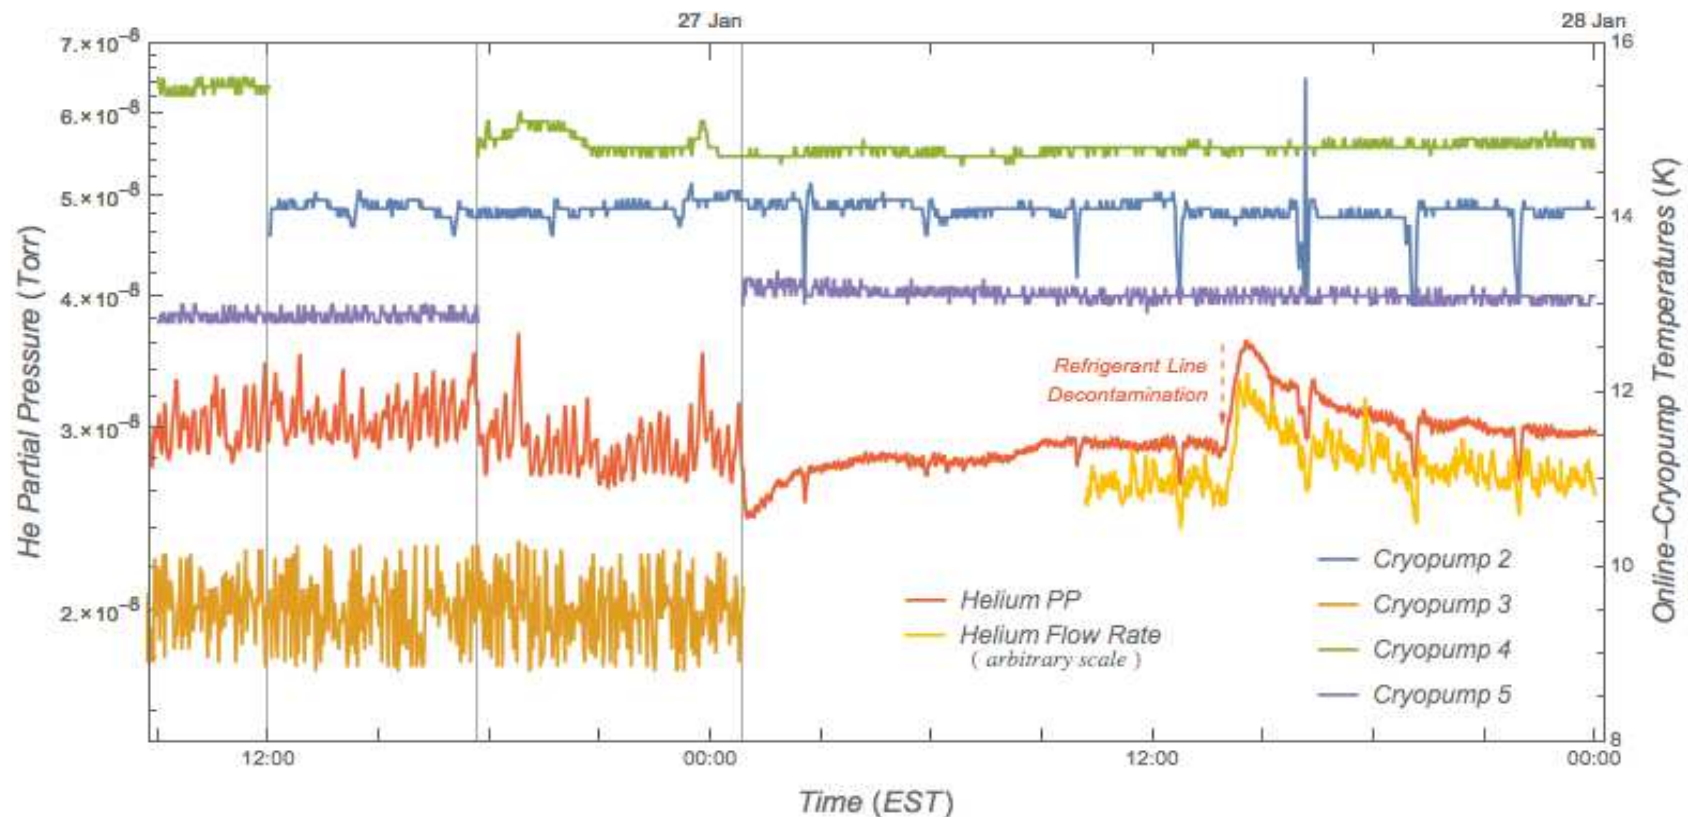
Chamber cryo-pump temperatures & helium partial pressures show a correlation that affects background helium levels within the chamber

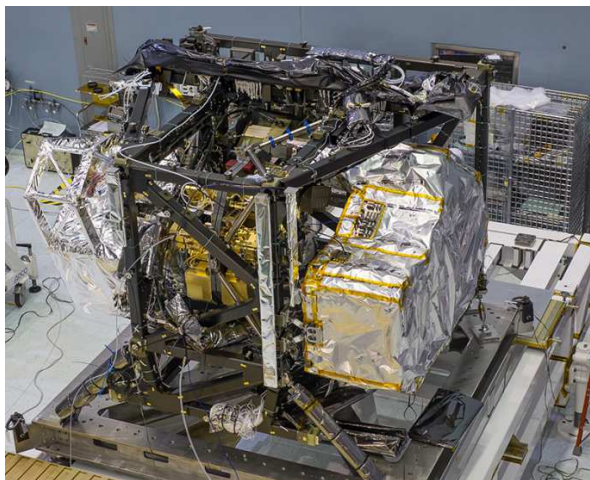
Refrigerant Lines and Line Support

- NIRCam new detectors arrays
- MIRI cooler flight unit (CV2 had flight-like assemblies: cooler lines and heat exchanger stage assembly, HSA)
- NIRSpec kinematic mounts change
- FGS guider detector assemblies
- New focal plane electronics

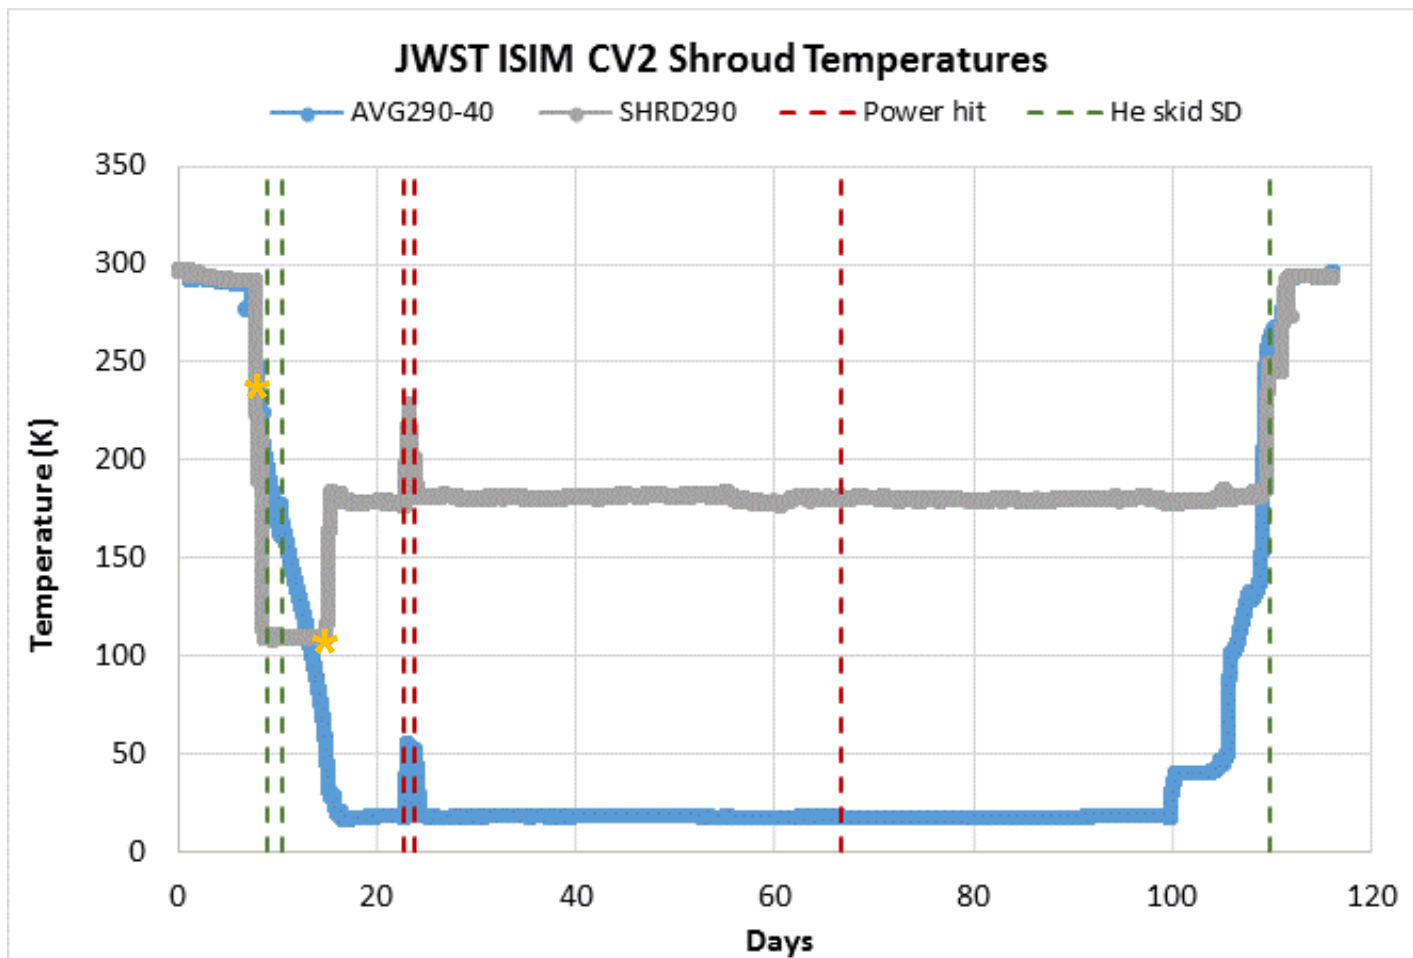
# Shrouds Temperature Performance

At steady state: Helium shroud average achieved:  $18\text{K} \pm 1\text{K}$  ||  $\text{LN}_2$  shroud average:  $180\text{K} \pm 3\text{K}$

\* = Switch  $\text{GN}_2 \rightarrow \text{LN}_2$  (DAY 8 – 6/24/14 03:44)  
 $\text{LN}_2 \rightarrow \text{GN}_2$  (DAY 15 - 6/30/14 22:40)

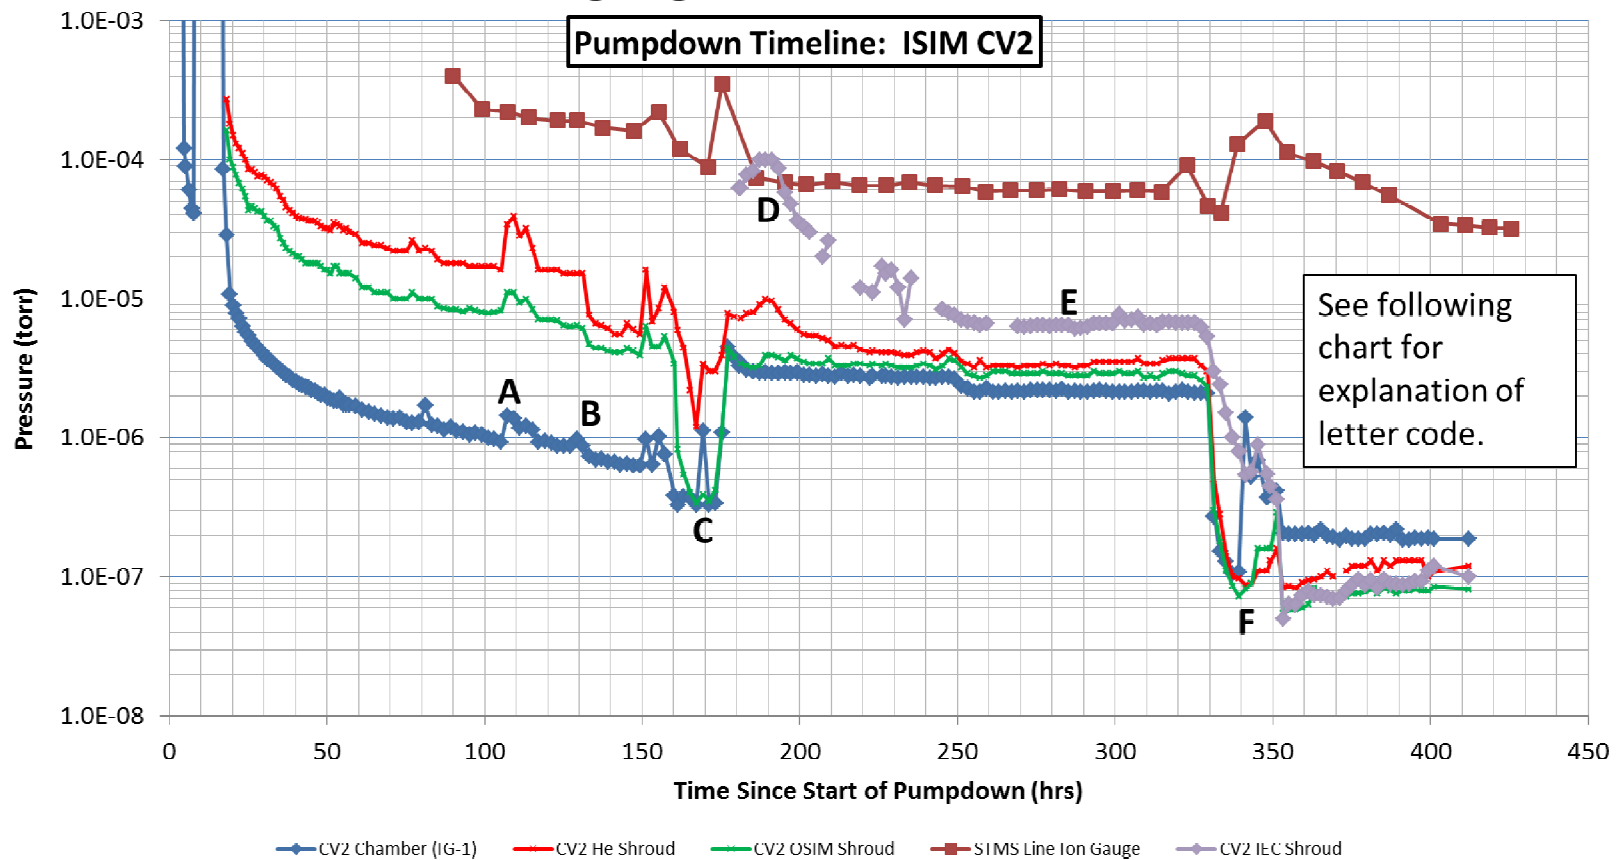
## 1) Redundant micro ion gauge for IEC

- A: Response to raising IEC N<sub>2</sub> panel temp
- B: Response to cooling of CQCM lines
- C: Adjustments to facility N<sub>2</sub> shroud
- D: IEC temperature cycle from 273-308 K and back, after which pressure continues to drop as IEC He panels get cold enough to sink water
- E: Pressure in IEC shroud stabilizes, though panels are 130K → 100K, with much lower water vapor pressure than P observed: **suggests an N<sub>2</sub> leak inside IEC shroud; need to check/fix before CV3**
- F: He panels reach temperature for sinking N<sub>2</sub>/O<sub>2</sub>; pressures everywhere plummet

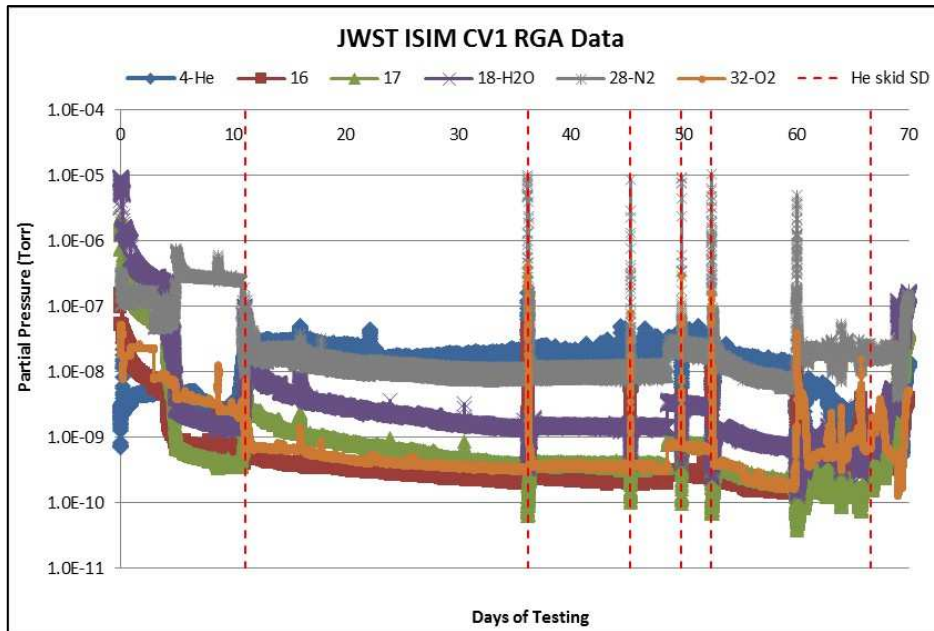
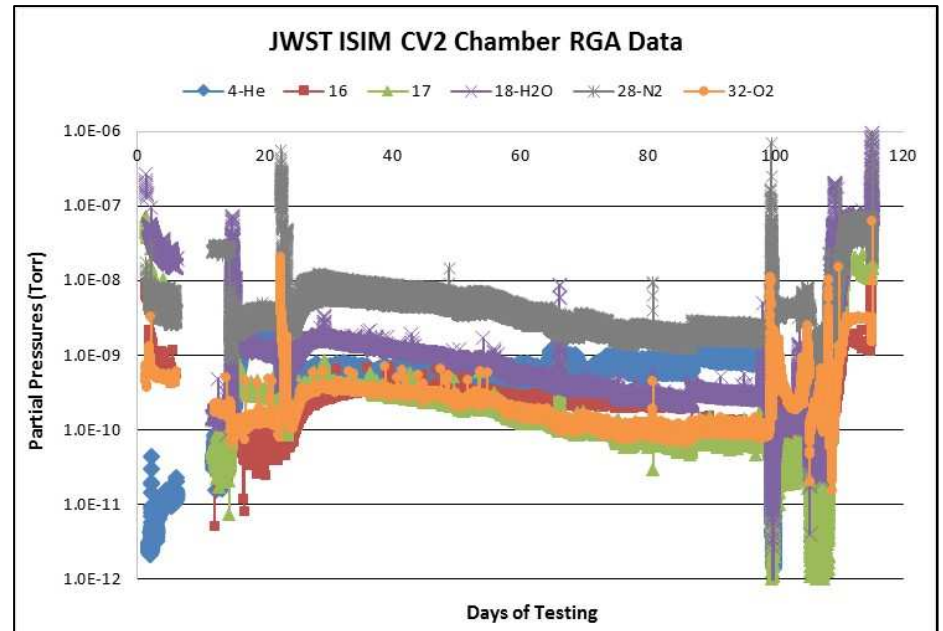
# CV1 vs. CV2 Chamber RGA Detection Levels

ISIM CV1: Chamber RGA detected helium levels around  $1.5 \times 10^{-7}$  Torr

ISIM CV2: Chamber RGA detected helium levels around  $1.0 \times 10^{-9}$  Torr

Levels of detected helium using chamber RGA decreased by almost two orders of magnitude from CV1 to CV2

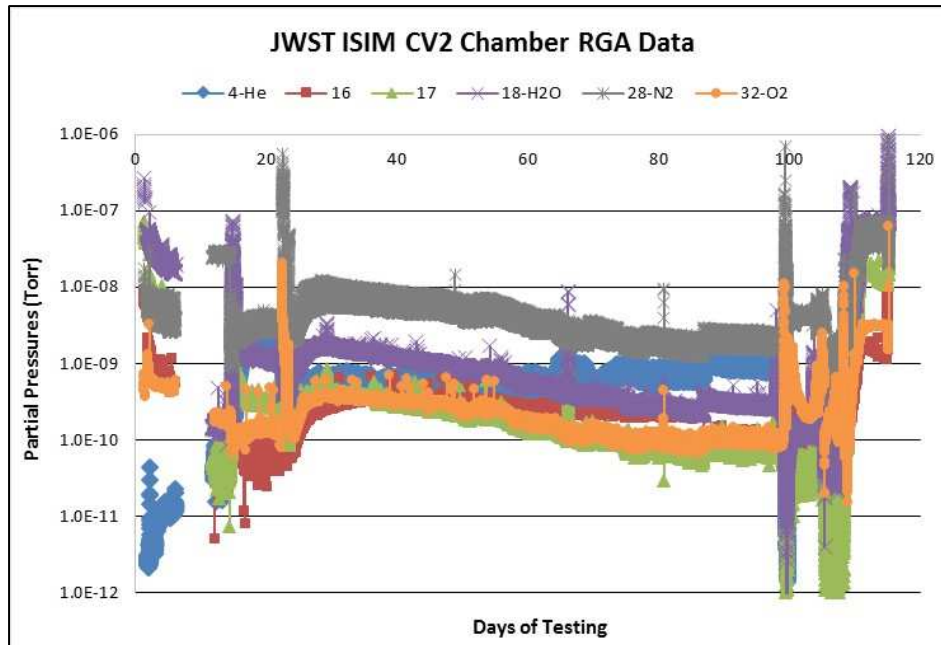
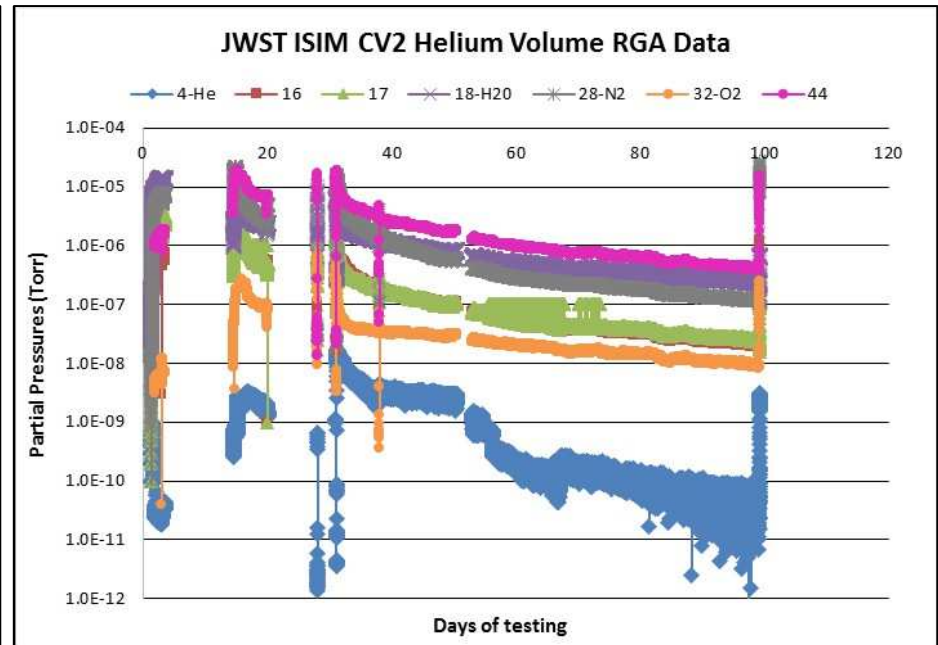
## CV2 Chamber RGA vs. Helium Volume RGA Detection

ISIM CV2 Chamber RGA detected helium levels around  $1.0 \times 10^{-9}$  Torr

ISIM CV2 ISIM/STMS volume RGA detected helium levels consistently  $<1.0 \times 10^{-8}$  Torr

ISIM CV2 Chamber RGA detected helium levels were more consistent throughout the test, whereas the detectable helium levels using the ISIM/STMS RGA slowly decreased throughout the test

Both in CV1 & CV2, the difference between the total chamber RGA partial pressure readings & the chamber IG pressure readings was  $\sim 2.0 \times 10^{-7}$  Torr higher pressure (lower vacuum) on the IG

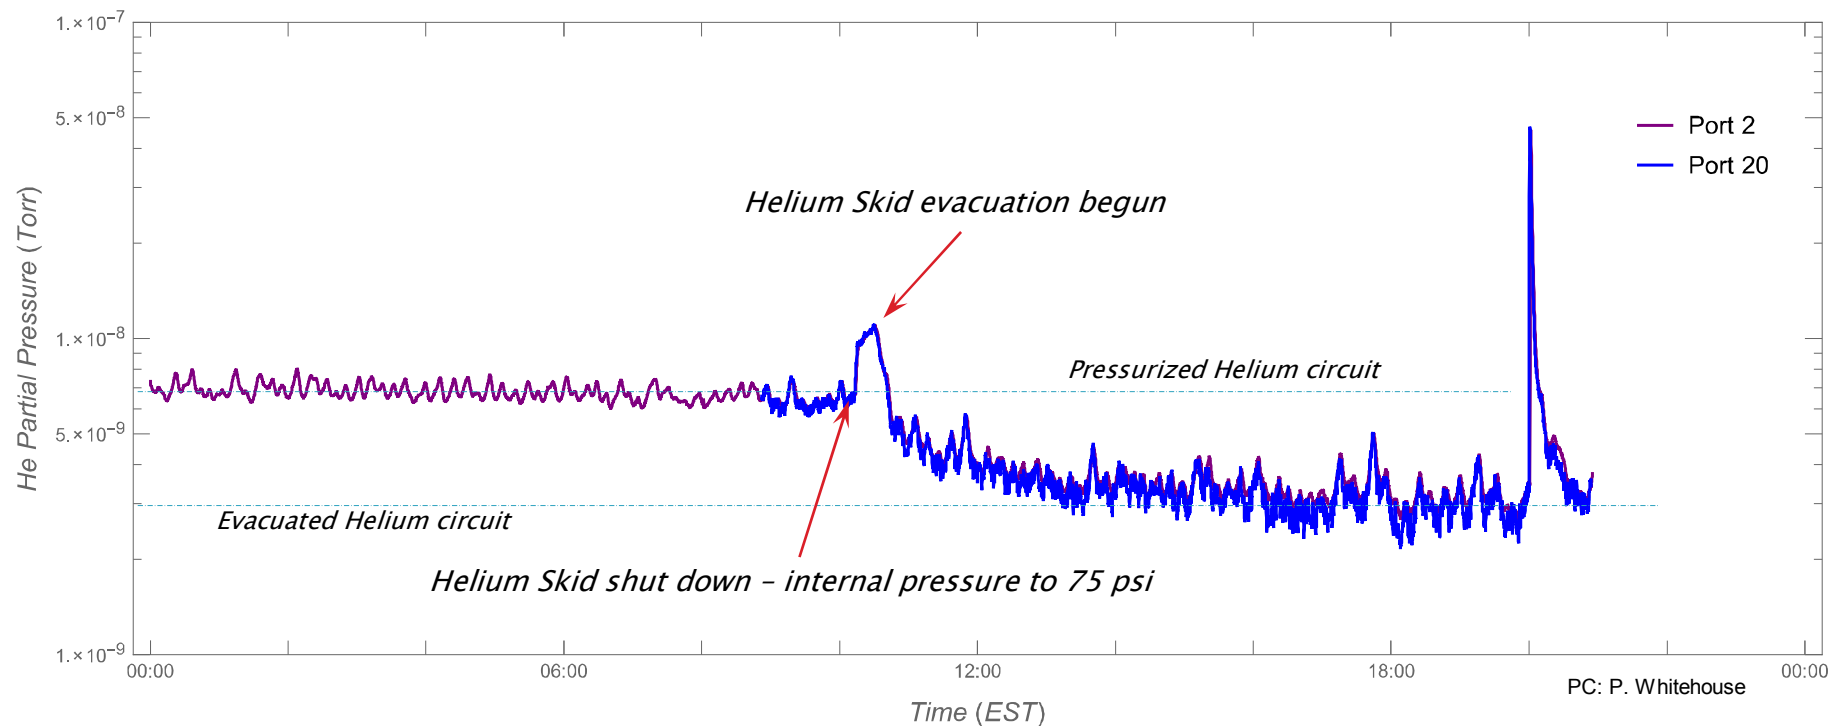
## Average Daily Helium Readings During Warm-Up

Readings between the two RGAs are consistent at warm temperatures

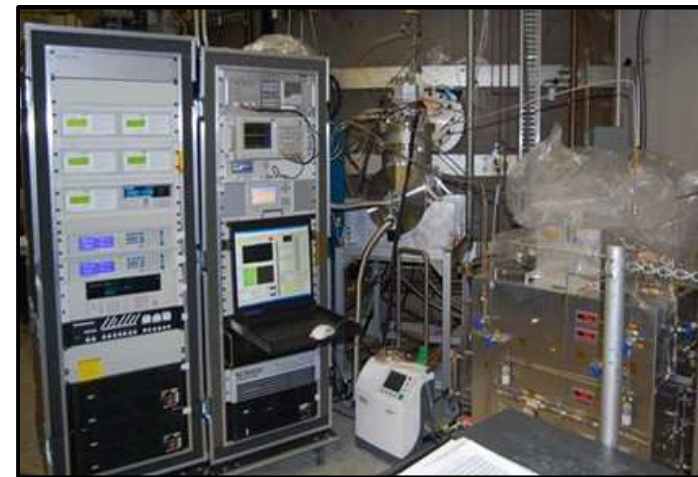
- 1) Redundant micro ion gauge for IEC
  - 2) New, calibrated RGA for helium shroud volume
  - 3) New cryopumps
- MIRI requirement: 6.2 K (-266.8°C) at the instrument
    - 2-stage cooler system
    - Accurate heat map required during environmental testing
  - Issues during CV1 & CV2
    - Measured heat loads to cooler from MIRI higher than expected
    - Presumed cause is higher levels of helium in chamber

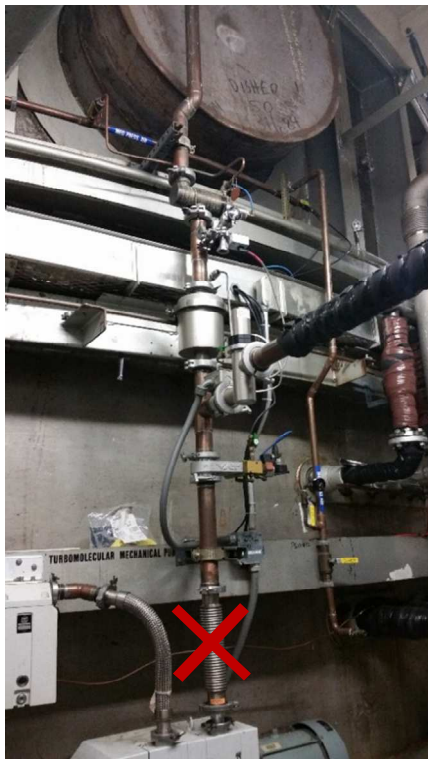
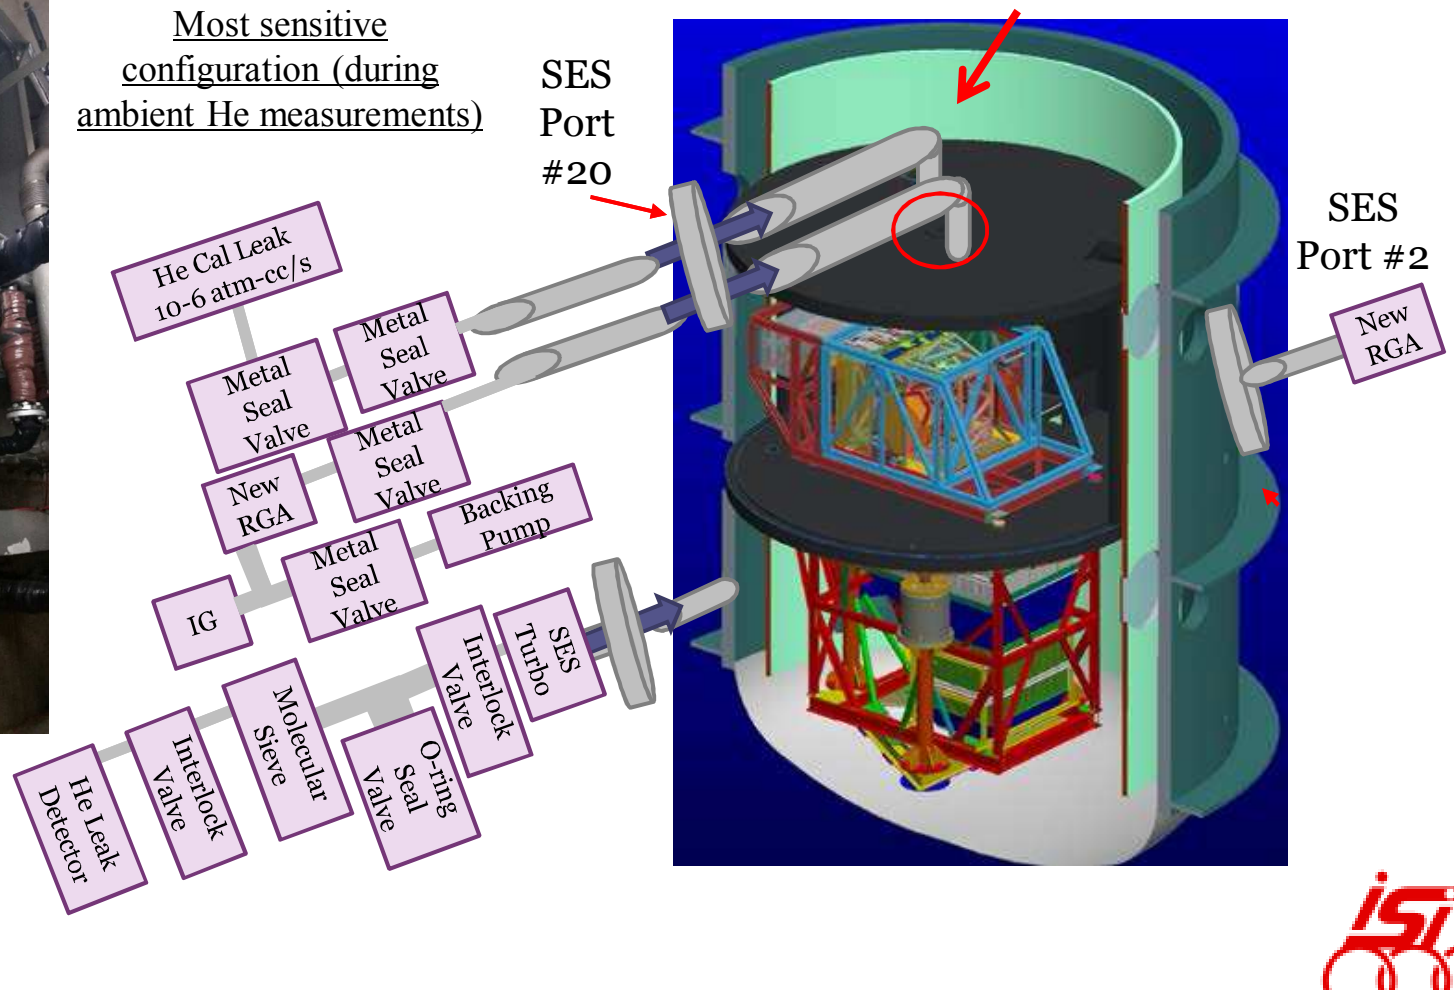
Most sensitive configuration (during ambient He measurements)

Entrance of two (1/2" SS line) tubing from chamber port thru the hole on the roof of He Shroud

SES Port #20

SES Port #2  
New RGA

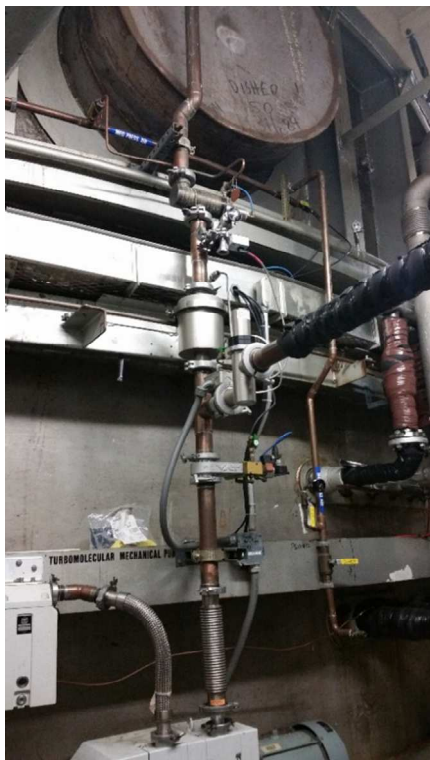
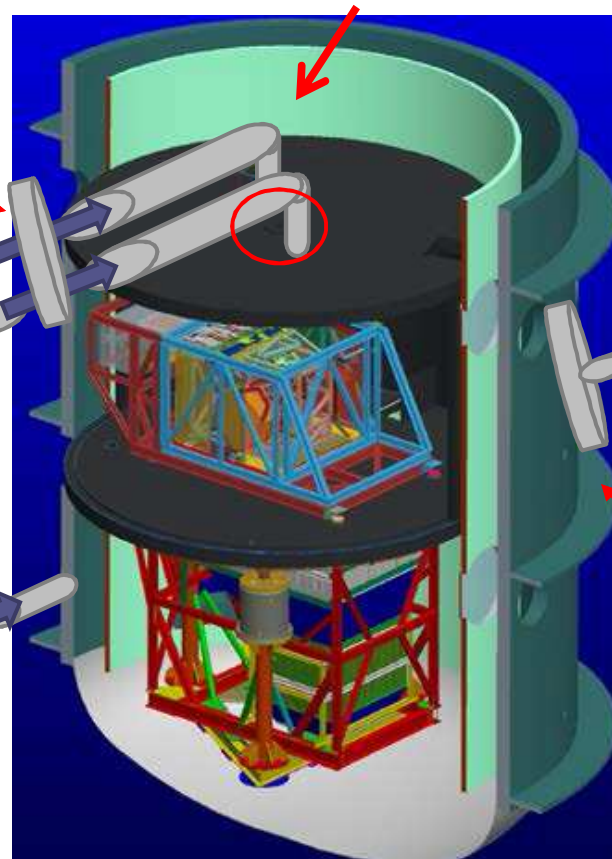
Less sensitive configuration  
(during cryo He measurements)

SES Port #20

Entrance of two (1/2" SS line) tubing from chamber port thru the hole on the roof of He Shroud

SES Port #2  
New RGA

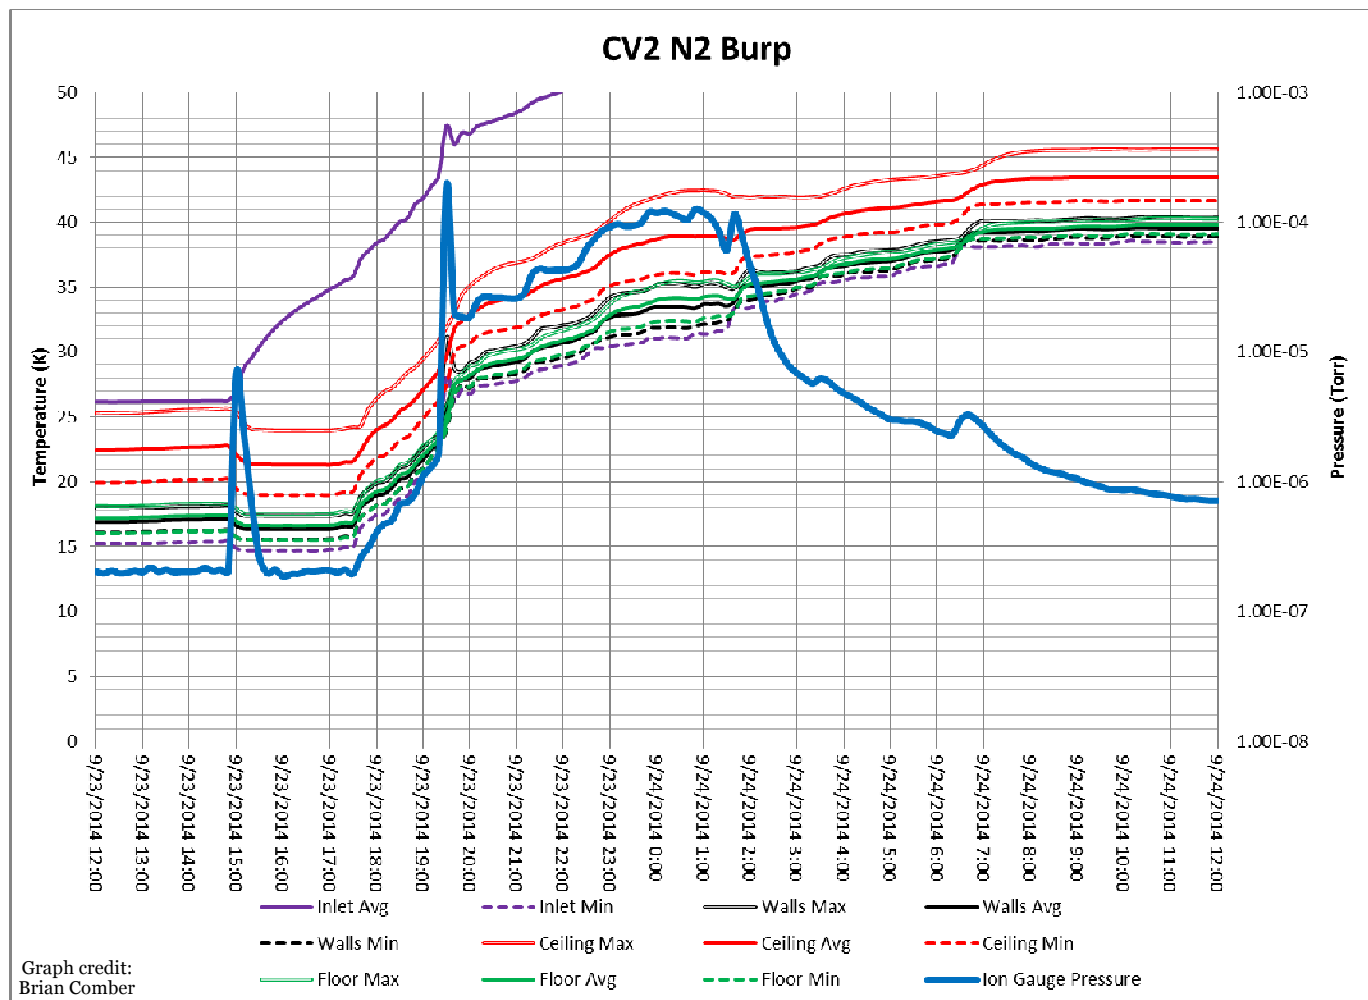
# The Nitrogen (and Oxygen) Burp

**Estimate of gas released: up to 700 g, or 0.65 torr, if released suddenly into the chamber → thermal effects would be significant**
